# CASE STUDY

## JOHNSONVILLE UNDERCUT REPAIR

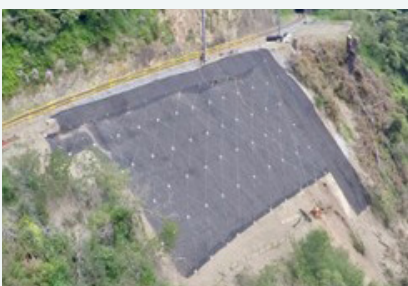
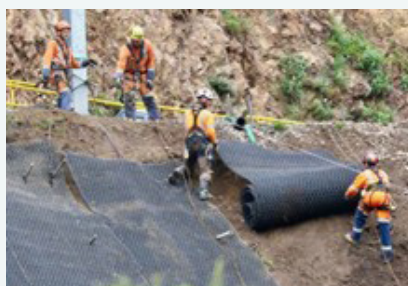
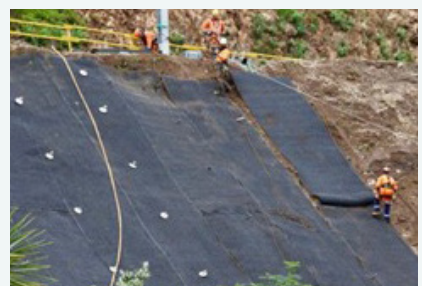
A custom scaffold system was erected to keep all work outside the rail corridor and clear of the overhead traction network, with access provided via a scaffold bridge spanning the stream below. Seventy BluGeo 25mm GRP rock bolts, selected for their corrosion resistance, were installed at 2.5m spacing and to a depth of 8m. Two anchors underwent suitability testing, loaded to 250kN in accordance with BS8081:2015. Casing was used to maintain the 100mm diameter drill holes through loose slip material until rock was reached. Drainage was incorporated through nine sub-horizontal PVC drains at 3m centres. The slope face was then covered with Geofabrics erosion control mesh (MacMatR), reinforced with diagonal 12mm galvanised wire ropes.

The six-week project was completed on schedule, meeting all KiwiRail quality assurance and health and safety requirements. The combination of corrosion-resistant anchors, integrated drainage, and reinforced mesh provided a durable solution to protect the rail corridor from further erosion.
