CASE STUDY

SIMEON QUAY SHOTCRETE

From May to July 2014, Abseil Access was contracted by City Care under the Stronger Christchurch Infrastructure Rebuild Team (SCIRT) to stabilise a loess slope above the Orion substation on Simeon Quay, Lyttelton. The slope had partially collapsed following drainage damage sustained during the 2011 Canterbury earthquakes. The objective was to restore stability and prevent further erosion while meeting SCIRT's strict quality and performance requirements.

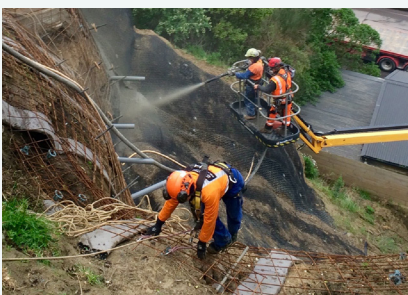
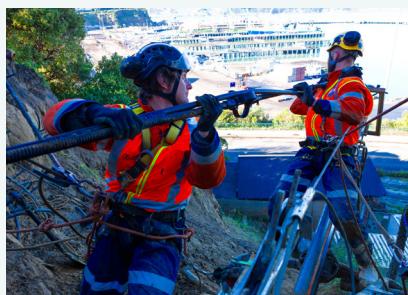
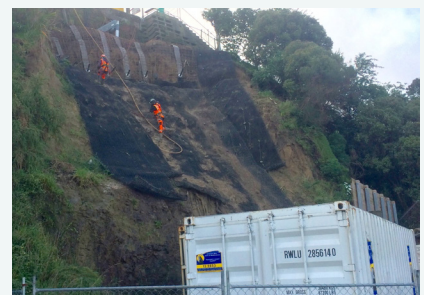
The stabilisation design featured a staggered soil nail grid consisting of 28 epoxy-coated steel tendons, each 25 mm in diameter, installed into 6 m deep, 150 mm diameter holes. Rope access and specialised cliff-face drilling equipment were used to complete all drilling. Four anchors were tested to design load after 72 hours, achieving 70 MPa grout strength at 28 days—well above specification. The lower slope was secured with Macmat-R netting, anchored with Duckbill erosion mat anchors installed using a pneumatic jackhammer. Once the upper slope was stabilised, geocomposite drainage strips and SE82 reinforcing mesh were applied, followed by a 150 mm layer of shotcrete applied via both rope access and an Elevated Work Platform.

The works were completed within the scheduled construction window, meeting all quality assurance requirements and exceeding SCIRT's design specifications. The Orion substation and surrounding area were left with a stable, reinforced slope, ensuring long-term protection from future erosion events.
